# BV FA MODULAR CHECKLIST-1 DAY (FAMILY DOLLAR SERVICES, INC.)

| Factory Name: | Shenzhen Greatfavoian Electronic Company Limited |

Coiling, SMT, Assembly and packing of decoration products, such as lighting glass, decoration lighting, etc.

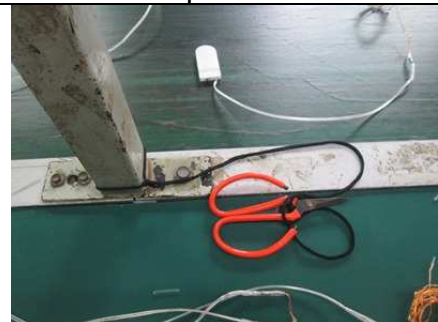
| 19) Sharp tool was well controlled and fastened to the workstation | 20) First piece sample | 21) MSDS |

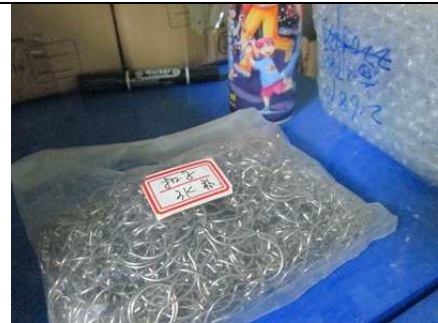
| Clause No. | Clause Requirement | Levels of Non-Conformance | Audit Findings |
|---|---|---|---|
| 1.3.1 | Raw materials (including packaging), work in progress and finished products shall be identified to ensure traceability. | Minor<br>( YELLOW ) | Most of raw materials, work in progress and finished products were properly identified, but some metal materials in hardware and electronic materials warehouse and some packaging materials in packaging materials warehouse were not well identified with PO number, quantity, specification, incoming date, etc., which could not ensure the effective traceability. |

| 22) Some metal materials in hardware and electronic materials warehouse not well identified | 23) Some packaging materials in packaging materials warehouse not well identified | 24) Some floors were not clean in assembly area |

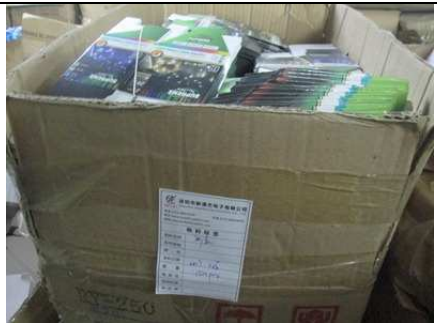
| Clause No. | Clause Requirement | Levels of Non-Conformance | Audit Findings |
|---|---|---|---|
| 3.4.2 | Materials and products are used in the correct order. Where appropriate, materials and products are used within the allocated shelf of usage life. | Minor<br>( YELLOW ) | By factory tour, some metal materials in hardware and electronic materials warehouse and some packaging materials in packaging materials warehouse were not well identified with incoming date to ensure FIFO. |

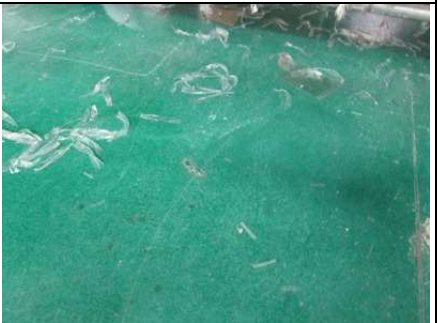
| Clause No. | Clause Requirement | Levels of Non-Conformance | Audit Findings |
|---|---|---|---|
| 2.5.1 | Cleaning practices shall be completed so as to minimise risk of contamination. | Minor<br>( YELLOW ) | Most of production workshops and warehouses were kept clean and tidy, but by factory tour, some floors were not clean in assembly area. |

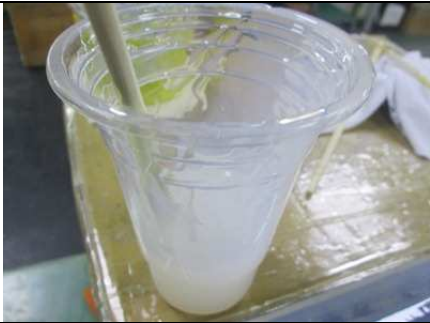
| Clause No. | Clause Requirement | Levels of Non-Conformance | Audit Findings |
|---|---|---|---|
| 2.9.1 | All Material Safety Data Sheets (MSDS) or equivalent documents are on file and up to date. | Minor<br>( YELLOW ) | Most of chemicals were well identified in the factory, MSDS were available in chemicals usage and storage areas, but by factory tour, one glue container used in SMT workshop was not well identified. |

| <p>25) One glue container used in SMT workshop not well identified</p> | <p>26) Some finished products stored close to the wall in finished products storage area</p> | <p>27) Some accessories placed on floor directly without pallets in hardware and electronic materials warehouse</p> |

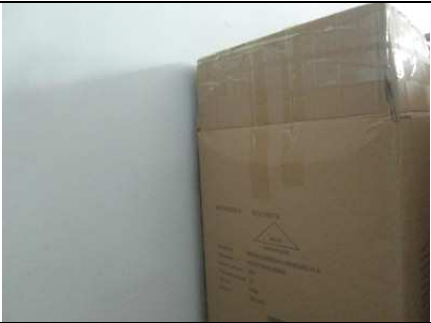
| Clause No. | Clause Requirement | Levels of Non-Conformance | Audit Findings |
|---|---|---|---|
| 3.4.1 | Procedures shall be in place to prevent the contamination of raw materials, packaging and finished products. | Minor<br>( YELLOW ) | Most of raw materials, packaging and finished products were well stored to prevent contamination, but by factory tour, some finished products were stored close to the wall in finished products storage area, some accessories were placed on floor directly without pallets in hardware and electronic materials warehouse, etc. |

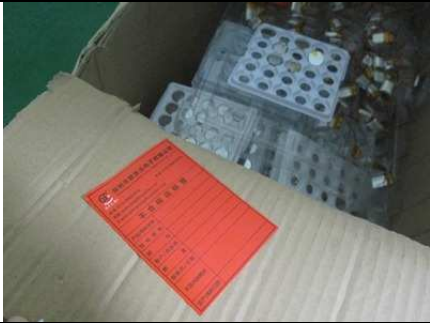
| Clause No. | Clause Requirement | Levels of Non-Conformance | Audit Findings |
|---|---|---|---|
| 3.7.1 | The company shall establish procedures for the identification, segregation, investigation and disposition of non-conforming raw materials (including packaging), work-in-progress and finished products. | Minor<br>( YELLOW ) | Most of non-conforming materials were well segregated, but by factory tour, some non-conforming materials were not well identified with reject cause, quantity, incoming date, etc. in non-conforming materials storage area. |

| <p>28) Some non-conforming materials not well identified in non-conforming materials storage area</p> | <p>29) One set electronic balance used in hardware and electronic materials warehouse not calibrated</p> | |

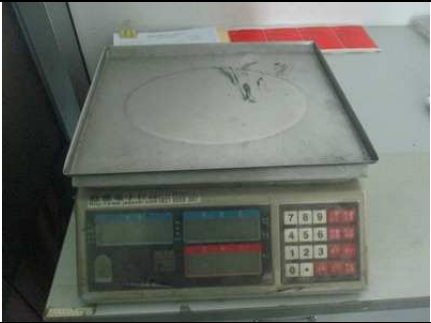
| 4.7.2 | Measuring and monitoring equipment is routinely calibrated to recognised national standards. | Minor<br>( YELLOW ) | Most of measuring and monitoring equipment was routinely calibrated, related calibration records were well maintained, but by factory tour, one set electronic balance used in hardware and electronic materials warehouse was not calibrated. |
| 4.7.3 | Records of equipment calibration and re-calibration are maintained. | Minor<br>( YELLOW ) | By factory tour, one set electronic balance used in hardware and electronic materials warehouse was not calibrated, so no calibration record was maintained for it. |
